Coal Burner Condition and Estimated Remaining Life Evaluation

Final Report

Intermountain Generating Station

Energy & Environmental Research Corporation

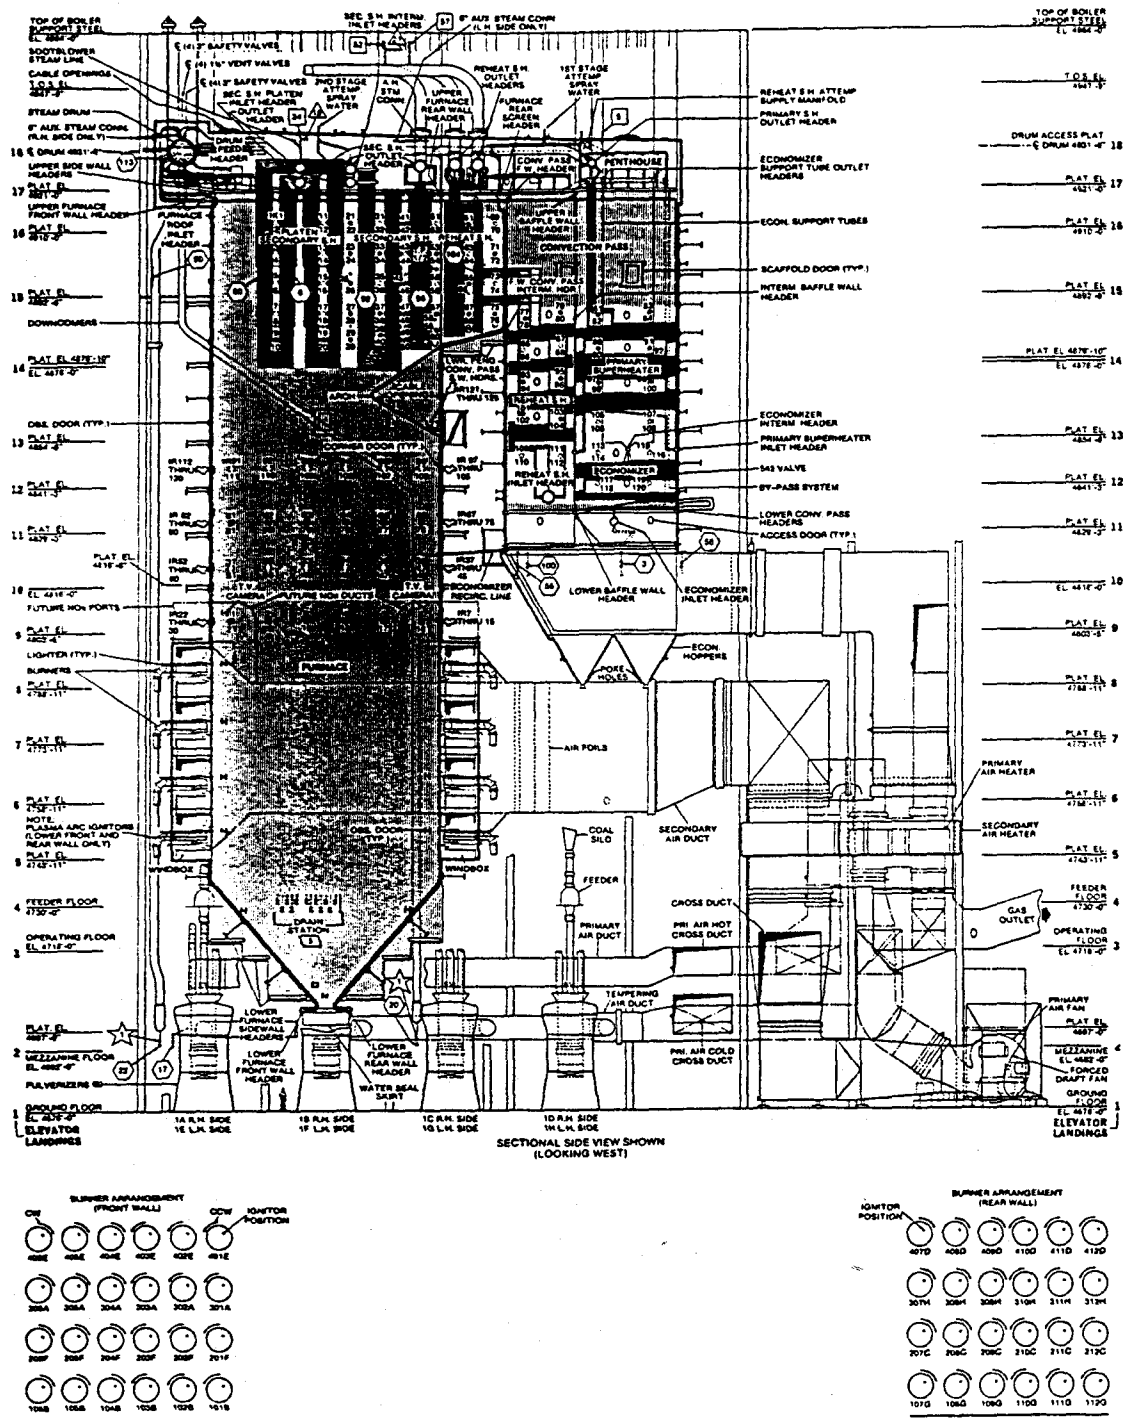
**INTERMOUNTAIN POWER PROJECT
UNIT NO. 1
LYNN DYLL, UTAH**

Intermountain Generating Station (IGS) Units 1 ^{and} 2 are indoor, balanced draft, parallel back-end, Carolina Type Radiant Boilers provided by the Babcock & Wilcox Company. Each unit fires pulverized coal from ^{a combination of the} forty-eight high input dual-register burners arranged in four rows of six burners on both the front and rear furnace walls. The burner windboxes are compartmented with air dampers located on each end. Furnace dimensions are 85 feet wide, 60 feet deep, and 299.5 feet from the lower wall header centerline to the drum centerline. Figure 1 illustrates the general boiler arrangement of the units.

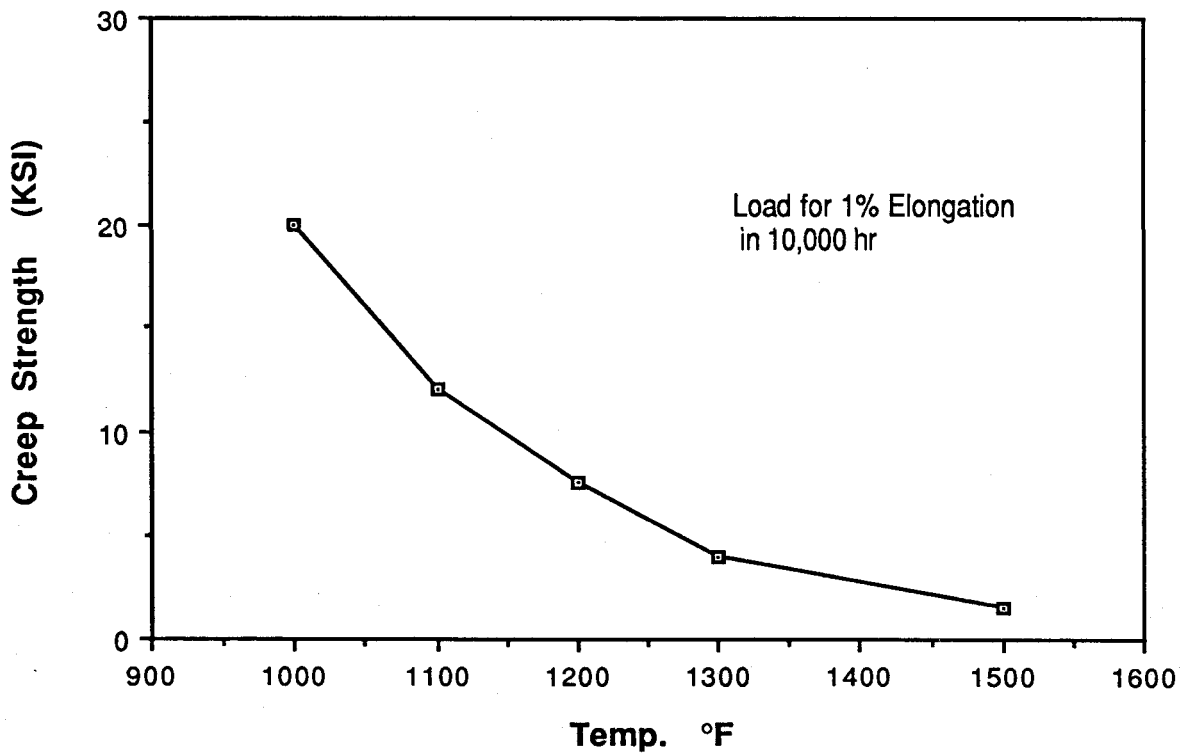
Creep Strength vs. Temp. for AISI 304 SST

The majority of the stainless steel material on this burner is AISI 304. Although the maximum operating temperature (with regard to oxidation resistance) of this ^{particular} stainless steel is several hundred degrees higher, the creep strength is greatly reduced at elevated temperatures. Creep strength is the ability to resist permanent strain that increases as a function of time under stress. Depending on the source, the creep strength of AISI 304 stainless steel is approximately 9.5 KSI at 1350°F. Figure 3 illustrates the creep strength vs. temperature relationship for 304 stainless steel. For a long term installation such as this burner the 304 stainless material should be limited to 1150°F. *which has 9.5 KSI creep strength.* *Creep Strength vs. Boiler Life Curve*
